Red Dog Home Inspections, Inc.

Anywhere in Portland, OR 97211
Inspection prepared for: My clients name
Real Estate Agent: Your real estate agent -

Date of Inspection: 1/1/2014 Time: 9 AM

Report Summary

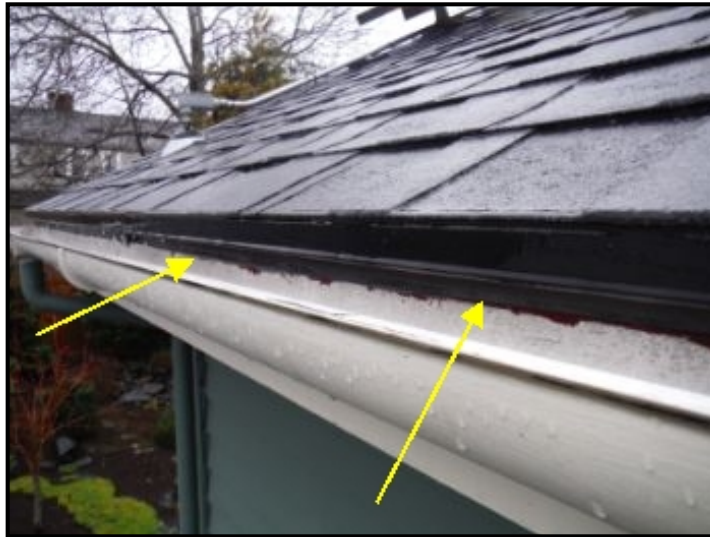
- The gutter drip edge flashing is too short in places; however the overhang of the starter course should be sufficient to keep the water from contacting the fascia board.
- Some downspouts have been disconnected from the rain drains and appear to be diverting the water away from the foundation via splash blocks.
- There is standing water in some of the gutters, I would suggest cleaning and adding screens at the downspouts.

Sample of gutter drip edge flashing being too short.

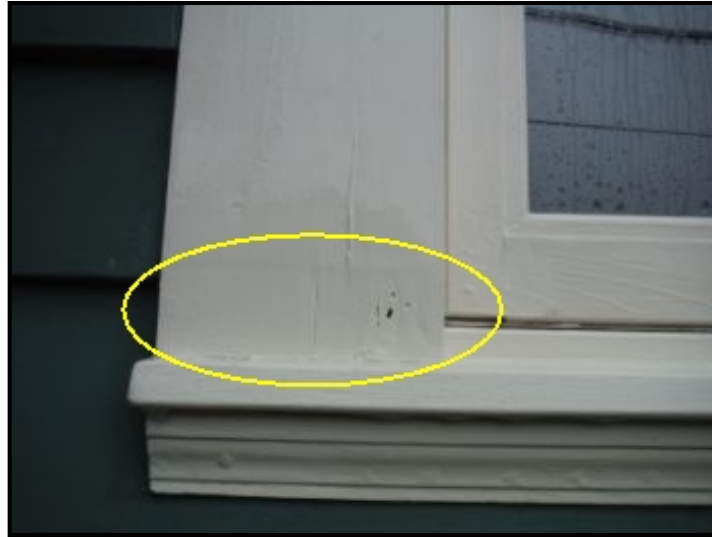
- There is a soft spot on the wood trim around the south dining area window. This area needs to be kept well sealed against moisture intrusion.

Small area of soft wood at south side window trim.

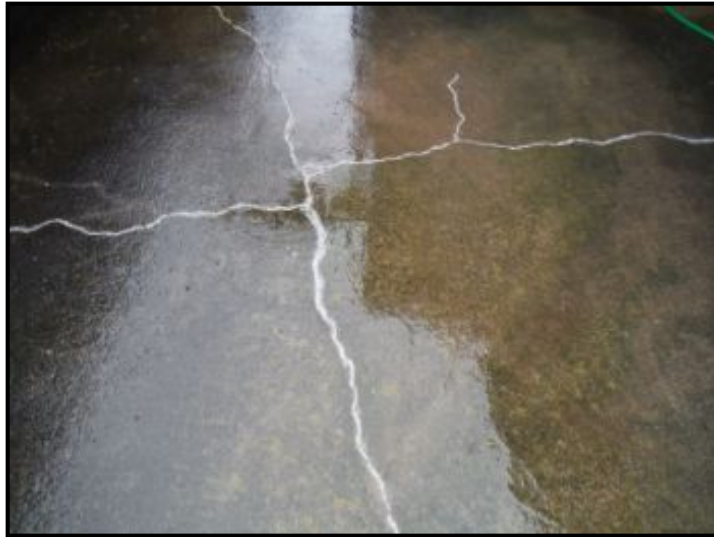
- Moderate cracks in driveway. Monitor for expansion and development of trip hazards.
- Some spalled concrete at the front sidewalk.

Sample of cracking in the driveway concrete.

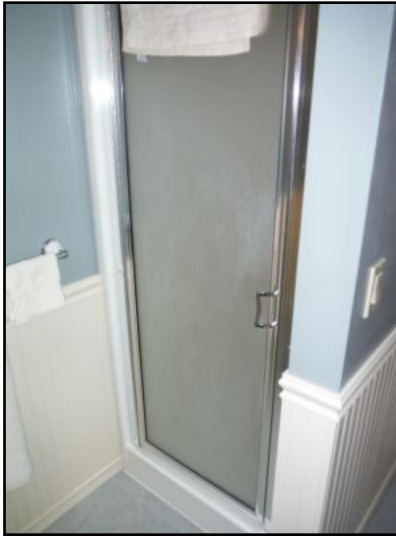
- Unable to determine if glass in the upper hall shower is tempered safety glass.

I could not confirm if glass door is tempered or not.

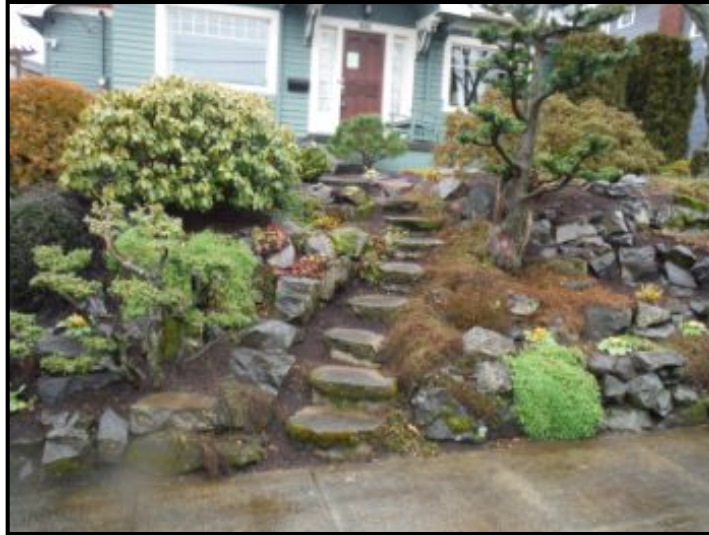
- There is a slight slope to the stair treads, common in older renovated homes.
- There are a couple of issues with the stairs leading to the basement i.e. - width of stairs and various riser heights. These are typical of older homes but would not meet the requirements of today's building practices.
- The stairs at the front of the property that leads up from the sidewalk lack a handrail and could pose a trip / fall hazard. Recommend evaluation.

The lack of a handrail on the front stairs could be a fall hazard.

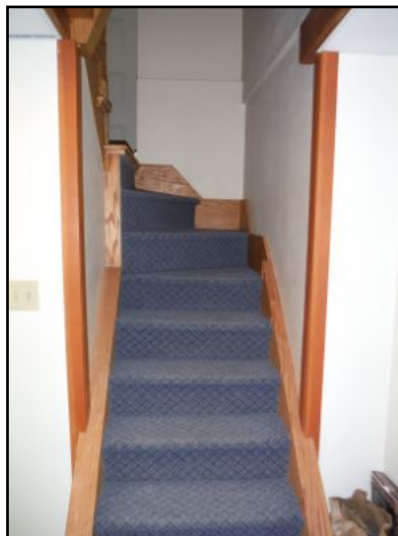
- The lower portion of the basement stairs are missing handrail.

The width, riser height and lack of handrail would not meet today's building standards.

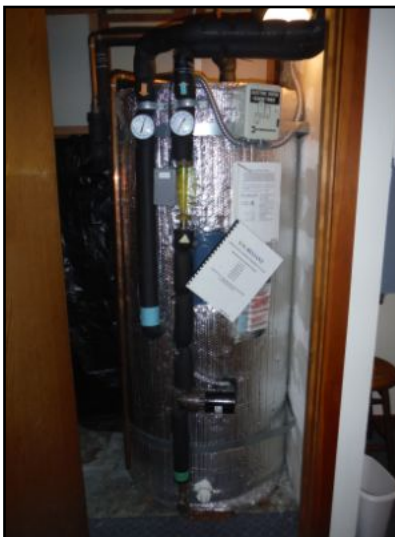
- The tank is wrapped in insulation, therefore the cabinet is not visible. I would imagine that the tank went in the same time as the solar power source, as a system. Recommend asking sellers.

View of the insulation wrapped water heater.

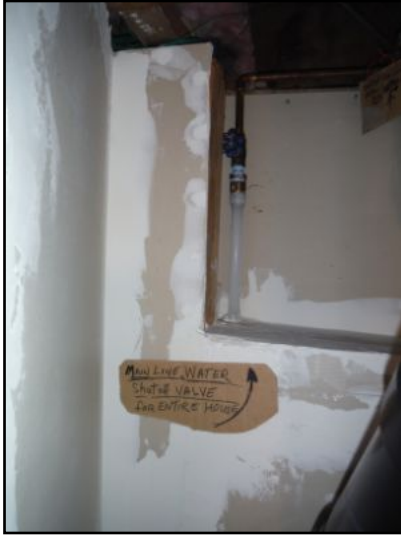
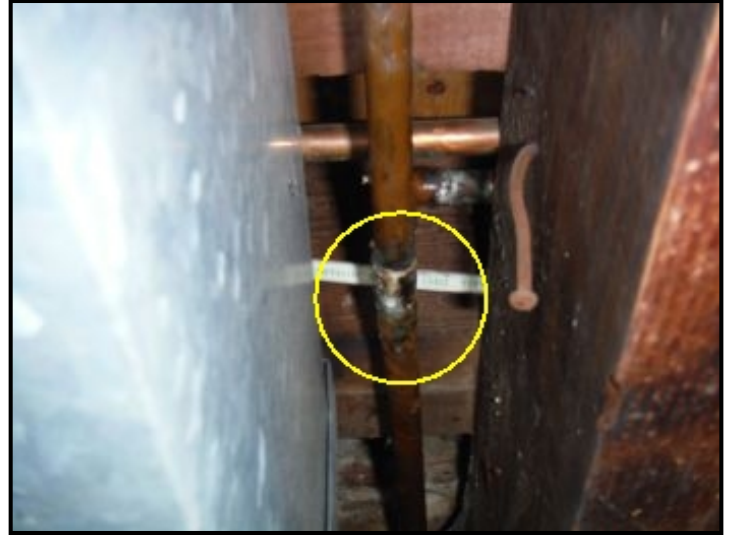
- Most of the piping is concealed and cannot be evaluated; however a small leak was observed at a copper union in a supply line located above and to the right of the furnace.

There is small leak at in the furnace room.

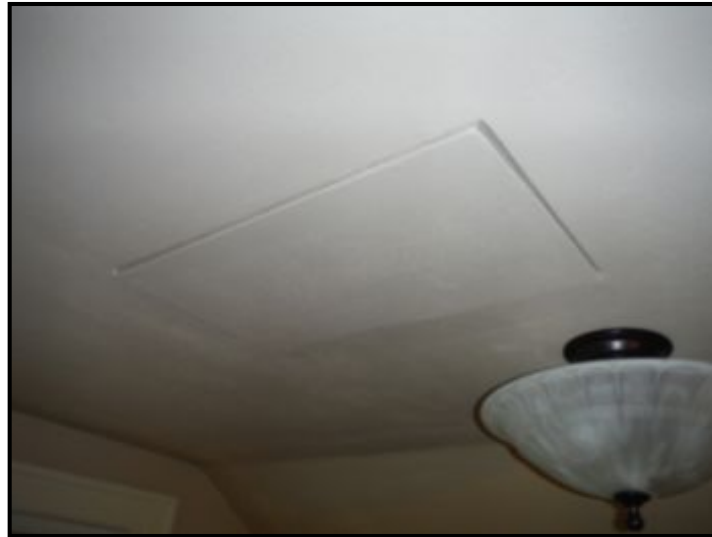
- There is a minimal access opening to the overhead attic space with insufficient headroom to safely crawl the attic. I was only able to partially view the original attic from the opening.

View of the minimally sized attic access.

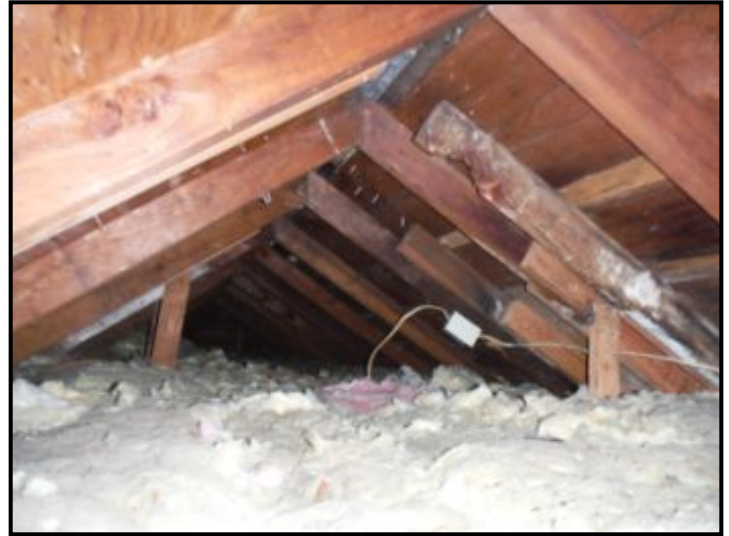
• I was able to partially view the upper attic from the opening. From this limited view I was able to see that some of the original framing components have been altered. Without having direct access to this framing, I cannot determine whether the structure has been compromised or improved. Recommend asking the sellers if there is any paperwork to indicate what work / changes were made.

Evidence of framing alterations in the upper attic.

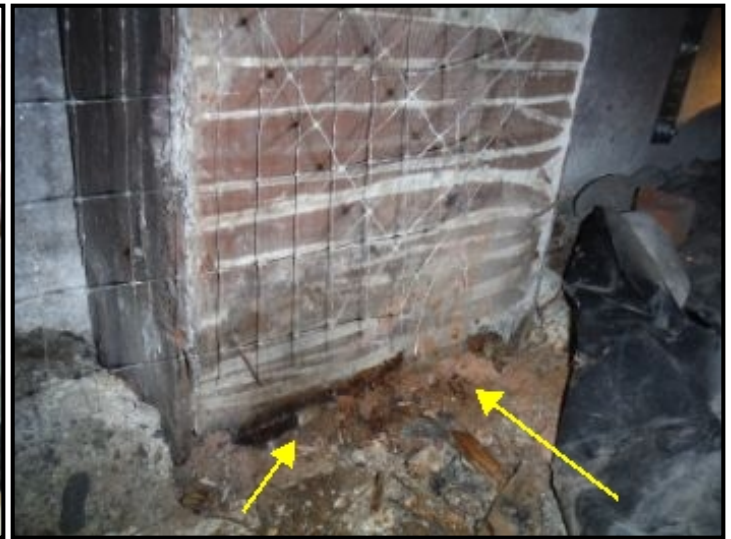
- Some cracks are evident in a couple places in the original foundation under the living room area. The cracking does not appear to be an ongoing issue.
- There is some active moisture intrusion on the south wall of the original crawlspace. Water is coming in through a crawl vent and saturating the sill and wall.
- There are some wood form boards that were left in the crawlspace under the fireplace. Some have rotted due to soil contact. Recommend removal.

Wood / soil contact with rot present.

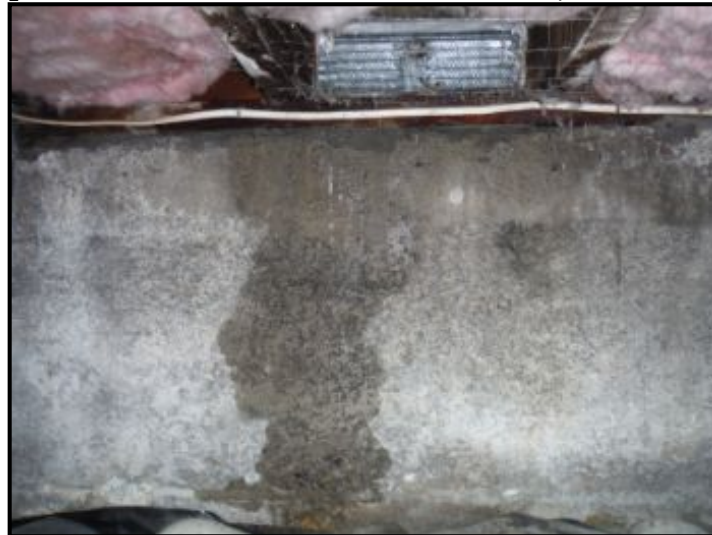
Evidence of moisture intrusion through vent screen.

- The venting is minimal, no visible adverse effects at this time.
- Moisture is entering through the vent screen on the south side of the original crawlspace.

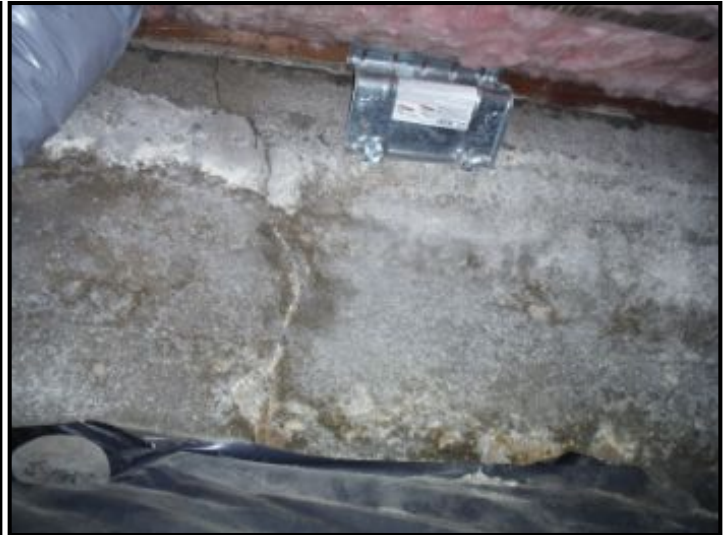
Sample of a foundation crack.
